Manhole Inspection Summary

Manhole # S11AA2007MH

Location Address: **2408 BRAMBLETON RD** Cross Street: **ROCKSPRING RD**

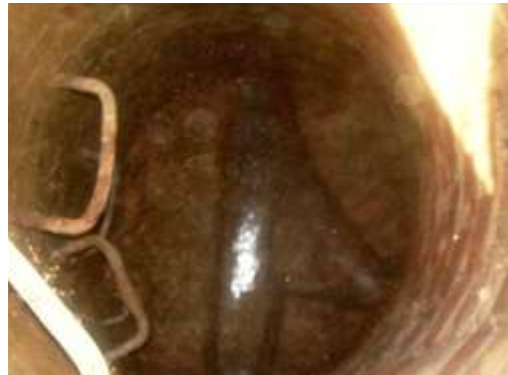
Top View

Bench ☒ Exists Material: **Brick** ☐ Parged ☒ **Debris** (not Condition related)
Condition: ☒ Sound ☐ Cracked ☐ Root Intrusion ☐ Deteriorated ☐ Leaks ☐ Debris

Steps Count: **5** Missing: **0** ☒ **Corroded**

Surcharge ☒ **Evidence Of Surcharge** Depth: **3** (ft.) ☐ Active Surcharge Present

Corroded steps. Evidence of surcharge - Bench debris.

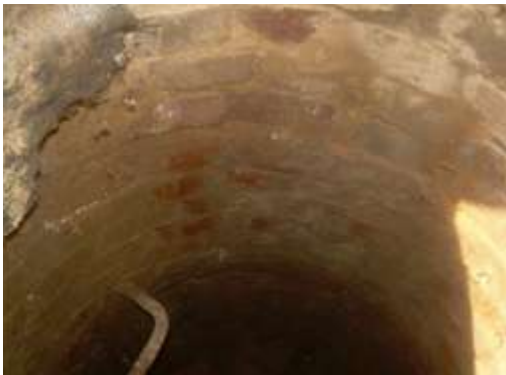
Defect

Chimney / Frame Adjustment ☒ Exists Material: **Brick** ☐ Parged Height: **6** (in.)
Condition: ☒ Sound ☐ Cracked ☐ Root Intrusion ☐ Loose Brick ☐ Deteriorated
Infiltration: ☐ None ☒ **Joint** ☐ Cracks ☐ Mortar ☐ Roots ☒ **Wall**

Corbel Material: **Brick** ☐ Parged Type: **Concentric/Eccentric**
Condition: ☒ Sound ☐ Cracked ☐ Root Intrusion ☐ Loose Brick ☐ Deteriorated
Infiltration: ☐ None ☐ Joint ☐ Cracks ☐ Mortar ☐ Roots ☒ **Wall**

Barrel Material: **Brick** ☐ Parged
Shape: **Circular** Diameter: **42** (in.) Length: (in.)
Condition: ☒ Sound ☐ Cracked ☐ Root Intrusion ☐ Loose Brick ☐ Deteriorated
Infiltration: ☐ None ☐ Joint ☐ Cracks ☐ Mortar ☐ Roots ☒ **Wall**

Adjustment, Corbel and Barrel infiltration.

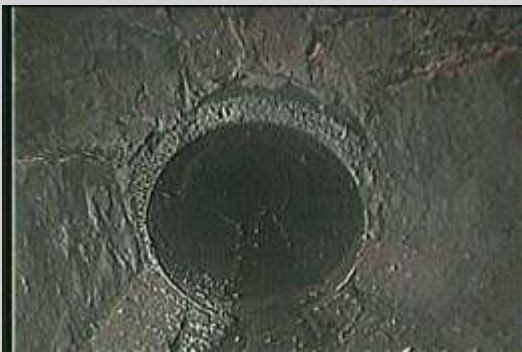
Pipe Out @ 12 O'Clock

Infiltration: **Evidence** Pipe Seal Cond: **Cracked**

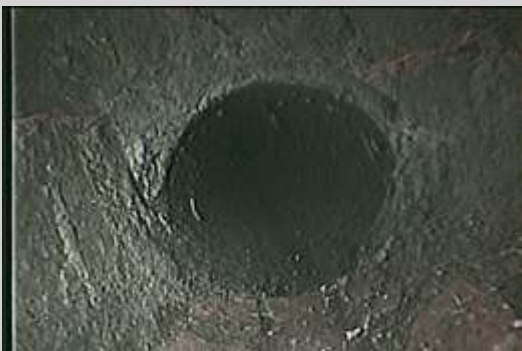
Pipe In @ 3 O'Clock

Infiltration: **None** Pipe Seal Cond: **Cracked**

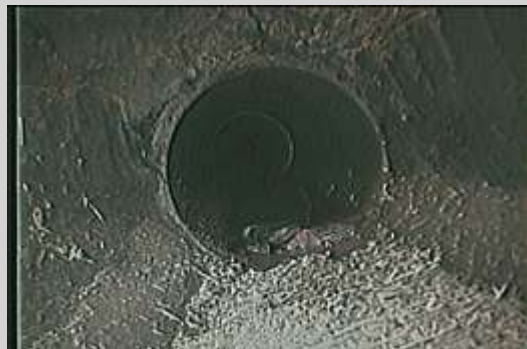
Pipe In @ 6 O'Clock

Barrel deterioration and infiltration.

Deposits: ☐ None ☒ **Mud** ☐ Sludge ☒ **Debris** ☐ Grease

Infiltration: **Evidence**

Pipe Seal Cond: **Cracked**
